**AFFIDAVIT OF CHARLES J. DINEZIO**

**Re: Kerri A. Ellis, Administratrix of the Estate of Susan Castell v.  
344 Providence Road Realty Trust et al.**

This letter report summarizes my findings regarding the above-referenced case.

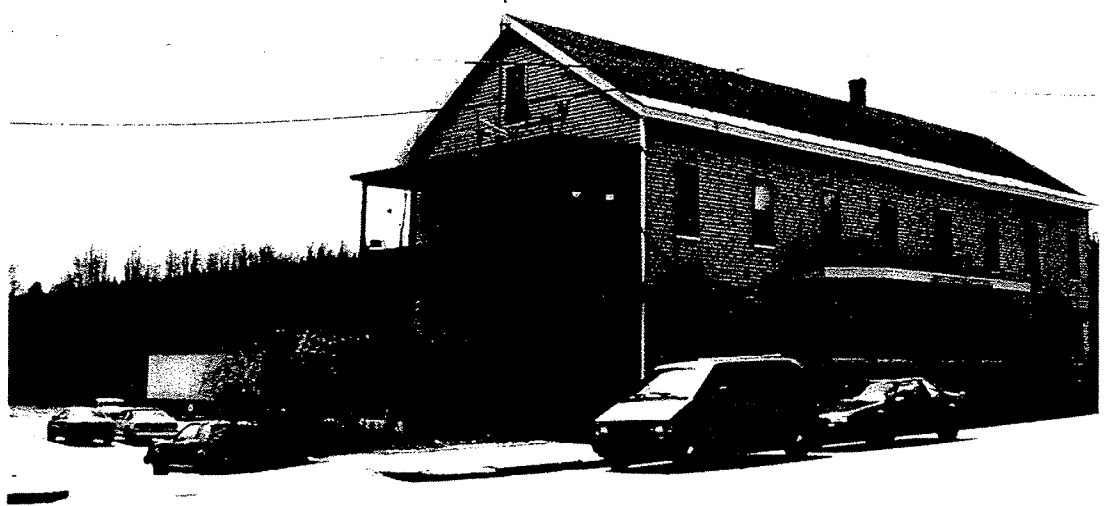
1330.033 VW pho 1.

- VW photo 1: 11-21 Sutton Street shown prior to the fire. The porch with single stair is shown at the gable end of the structure.
- VW photo 2: The other end of 11-21 Sutton Street shown prior to the fire. The restaurant is located in the protruding section at the ground floor.

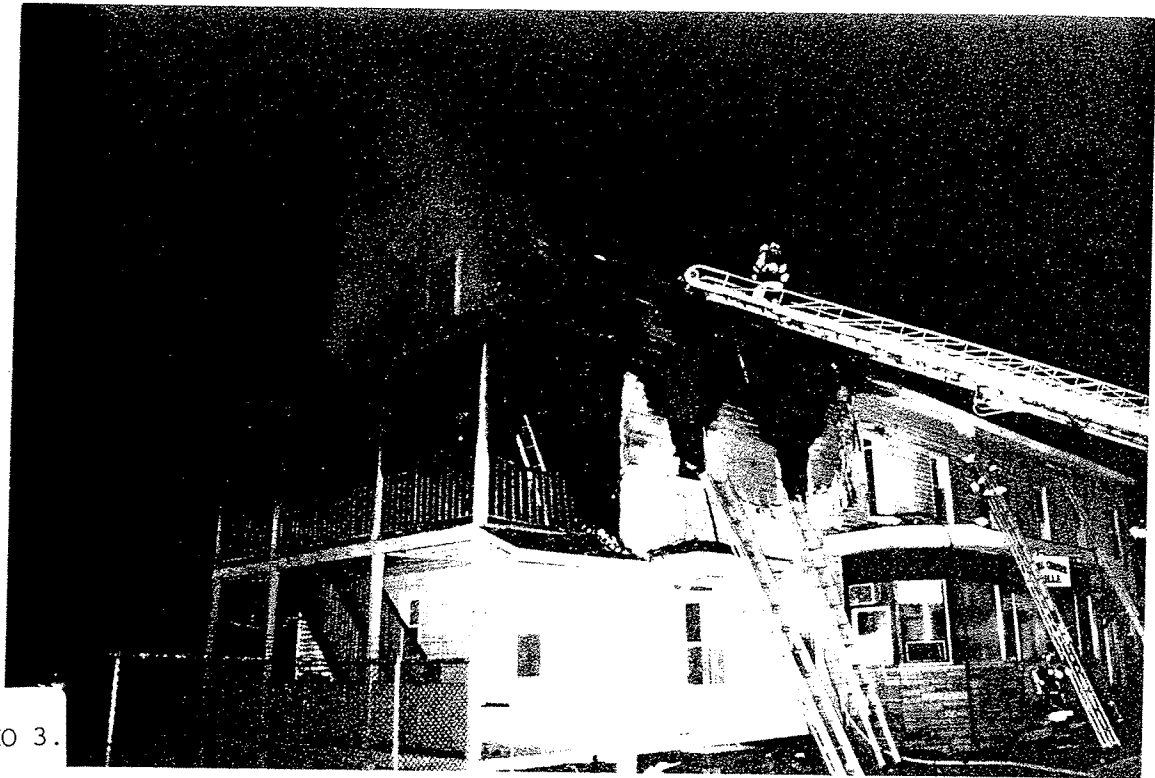
1330.033 VW PHO 3.

- VW photo 3: Firefighter operations underway on the morning of March 15, 2000. Smoke is pouring from Ms. Castell's apartment and the second floor porch appears heavily damaged by fire.

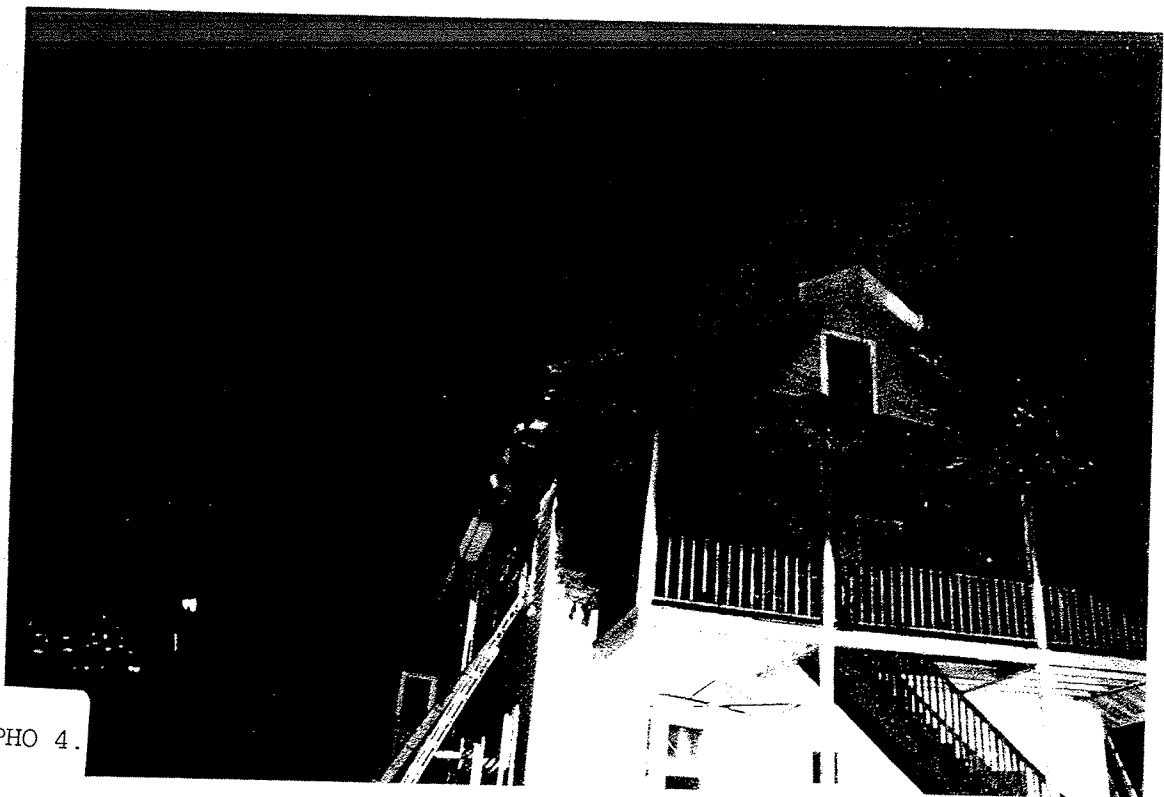
1330.033 VW PHO 4.

- VW photo 4: A different angle shows that the roof of the porch has served to contain and intensify the heat, smoke and flame from the fire as it makes its way through the two doors from Ms. Castell's apartment. The vinyl siding at the exterior wall at the porch indicates the intensity of heat at this location, the sole egress from Ms. Castell's apartment.

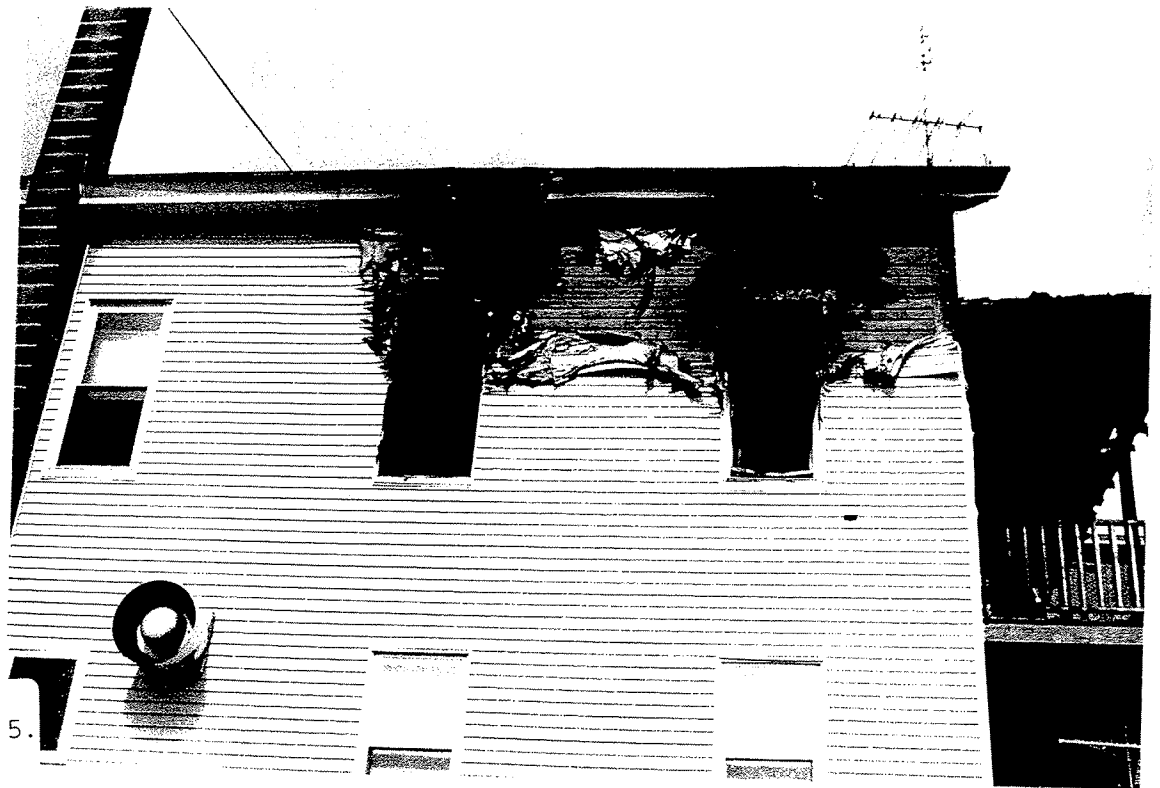
1330.033 VW PHO 5.

- VW photo 5: View of the two windows from Ms. Castell's apartment at the rear of the building taken shortly after the fire. Again, the heat of the blaze is indicated by the melted siding above and adjacent to the two windows.

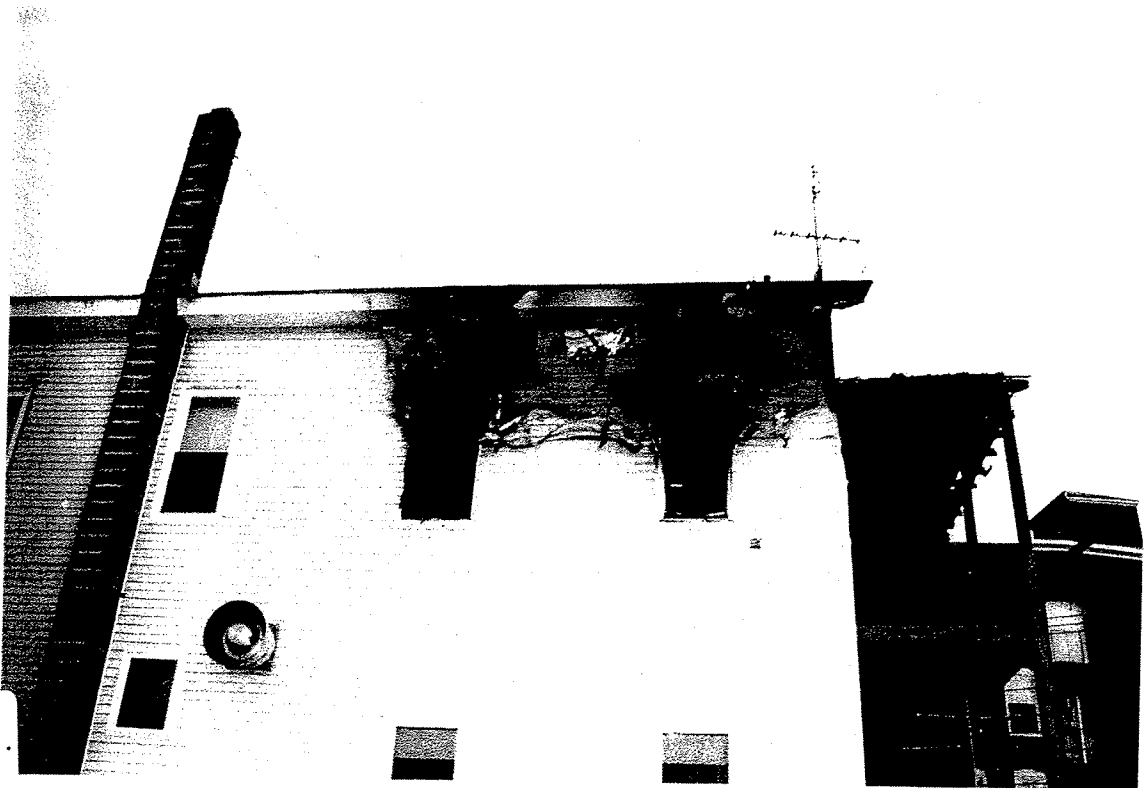
1330.033 VW PHO 6.

- VW photo 6: Similar view to #5.
- VW photo 7: Similar view to # 5.
- VW photo 8: The front of the building taken shortly after the fire. The extent of damage to the siding and roof is even greater than on the back side.
